Fix-It-Right

AUTOMATIC TRANSAXLE - NO MOVEMENT IN DRIVE OR REVERSE GEAR MODEL: ALL

TechNet Times

Volume 15 Issue 8 November 2005

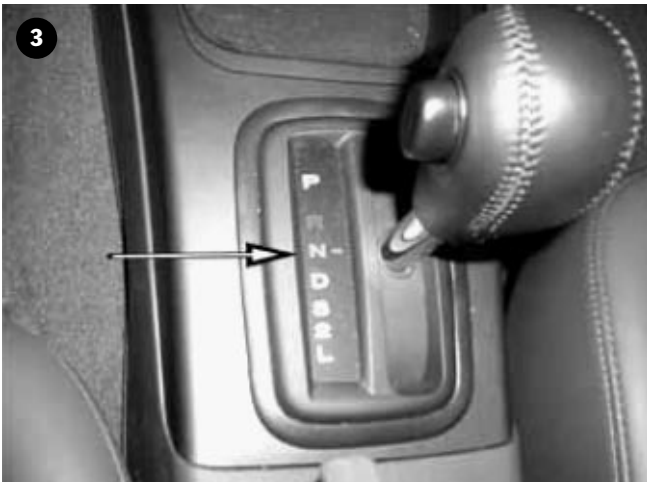
3. Move the shift lever to “N”.

4. Insert a 5 mm drill or M5 (5 mm) bolt in the adjustment hole of the range switch. Check that the drill or bolt fits into the adjustment holes.

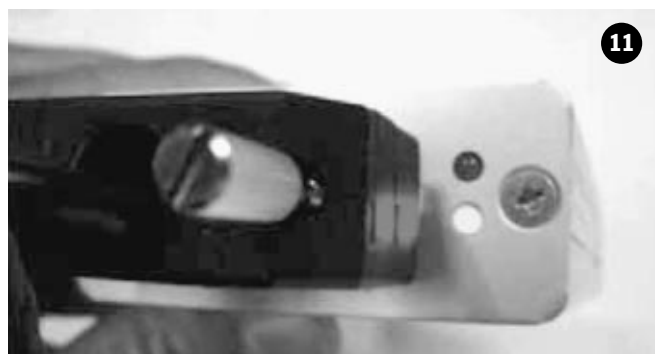
11. If the RED LED light blinks 4 times and then stays illuminated, the reprogramming was unsuccessful.

Check the following:

- Verify proper connection of the reprogramming tool cable to the vehicle's OCS connector.

- The power supply (voltage) at the cigarette lighter outlet may be too low.

Check the two conditions above. Disconnect the power adapter from the cigarette lighter outlet and reconnect to reset the reprogramming tool. Start the reprogramming procedure again. Go to Step #6 after successful programming.
